Settlement Investigation

The Aberdeen

2700 Paces Ferry Road SE
Atlanta, GA 30339

**Pavement, Sidewalk, Site-Wall, Parking Garage/Electrical
Room and Storm Drainage
Settlement Investigation**

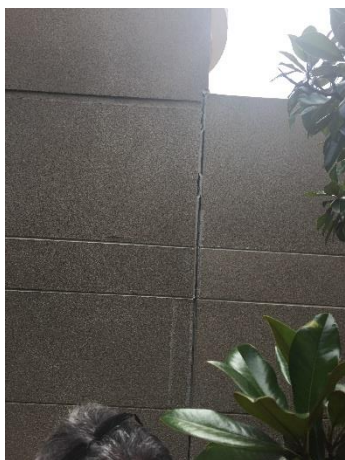
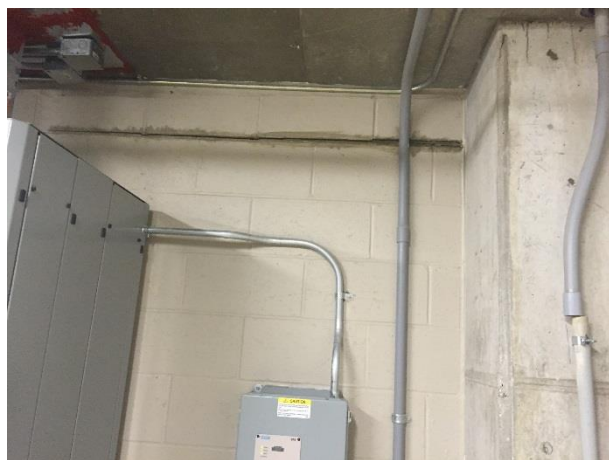
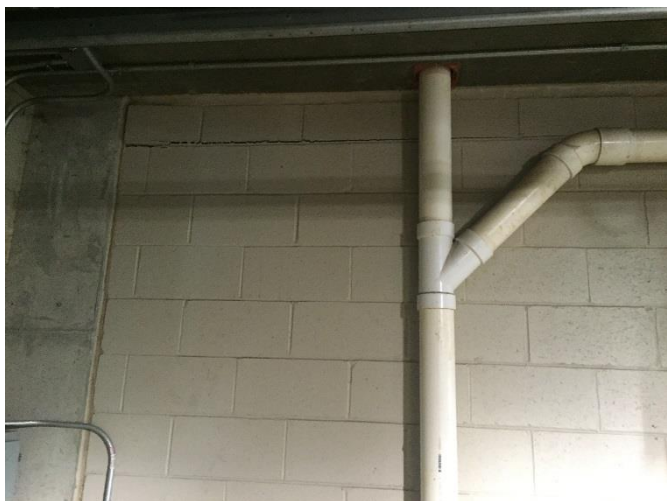
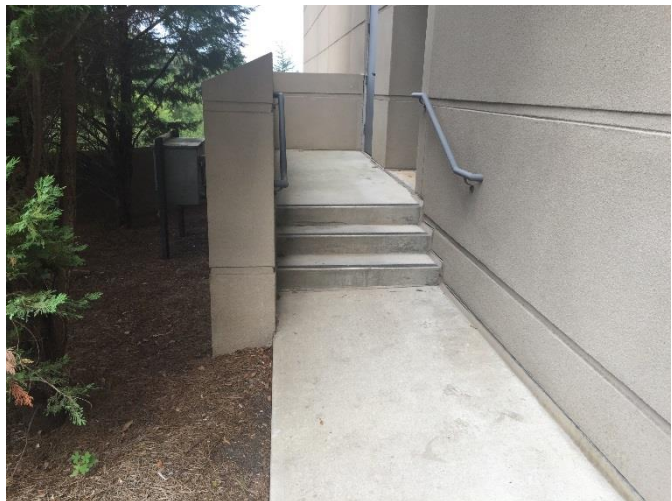
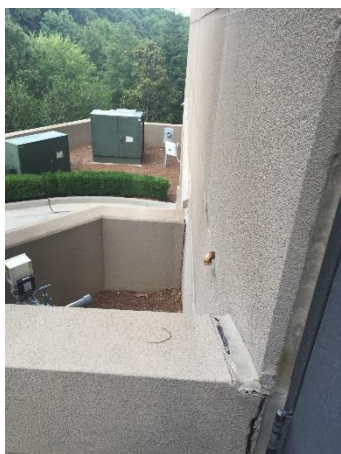
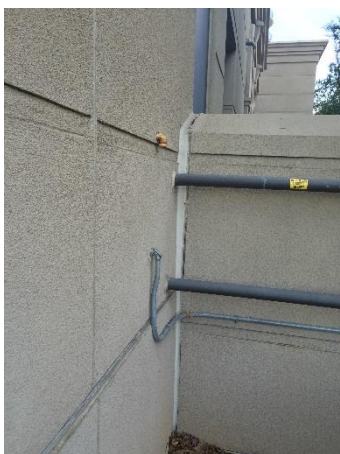
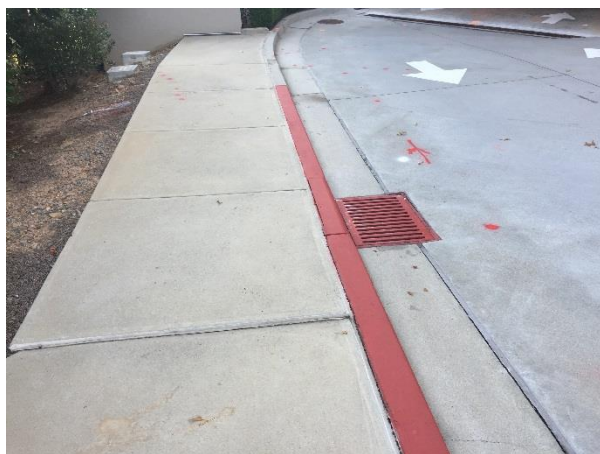
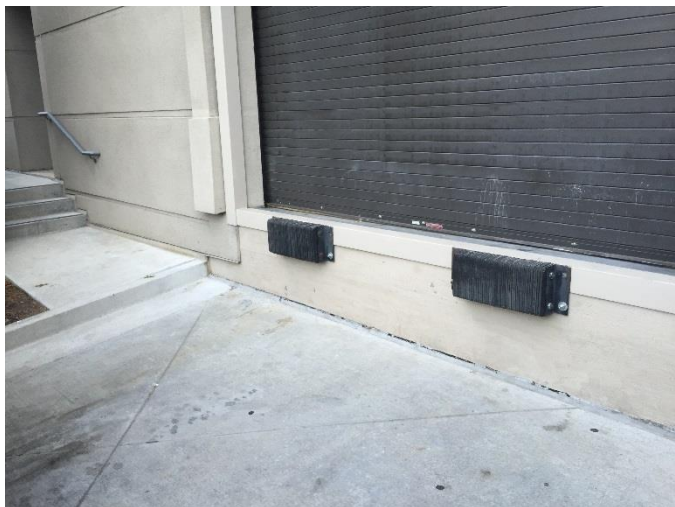
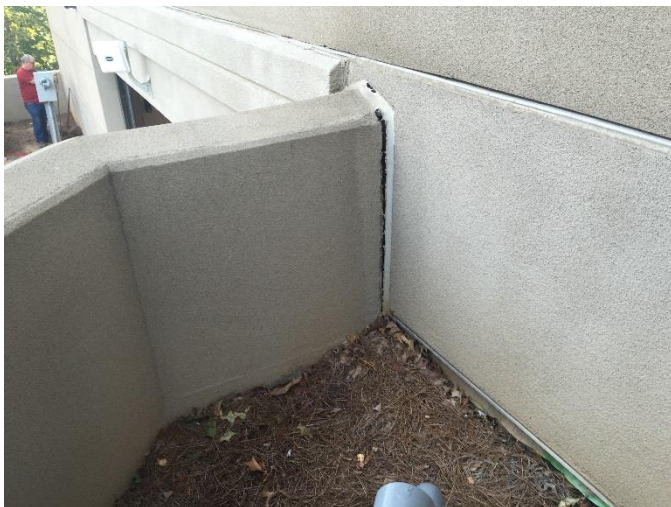
The preliminary findings of this investigation indicate that some of the settlement conditions are the result of as much as 25’ of marginally placed fill soil. This fill soil is consolidating into small voids within itself and causing surface structures (walls, pavements, etc.) constructed at the surface to settle.

Based on our findings, it appears that the settlement conditions of the surface structures can be stabilized against future settlements using a combination of Foundation Underpinning and Pressure (Injection) Grouting for Soil Stabilization. We recommend Underpinning the Heavier Loaded Structures with Foundation Piers (Piles) and Stabilizing the fill soil within the whole affected area with Injection Grouting. I am attaching a Sectional Detail of both of these services along with some photographs of the resulting signs of significant settlement of the surface structures.

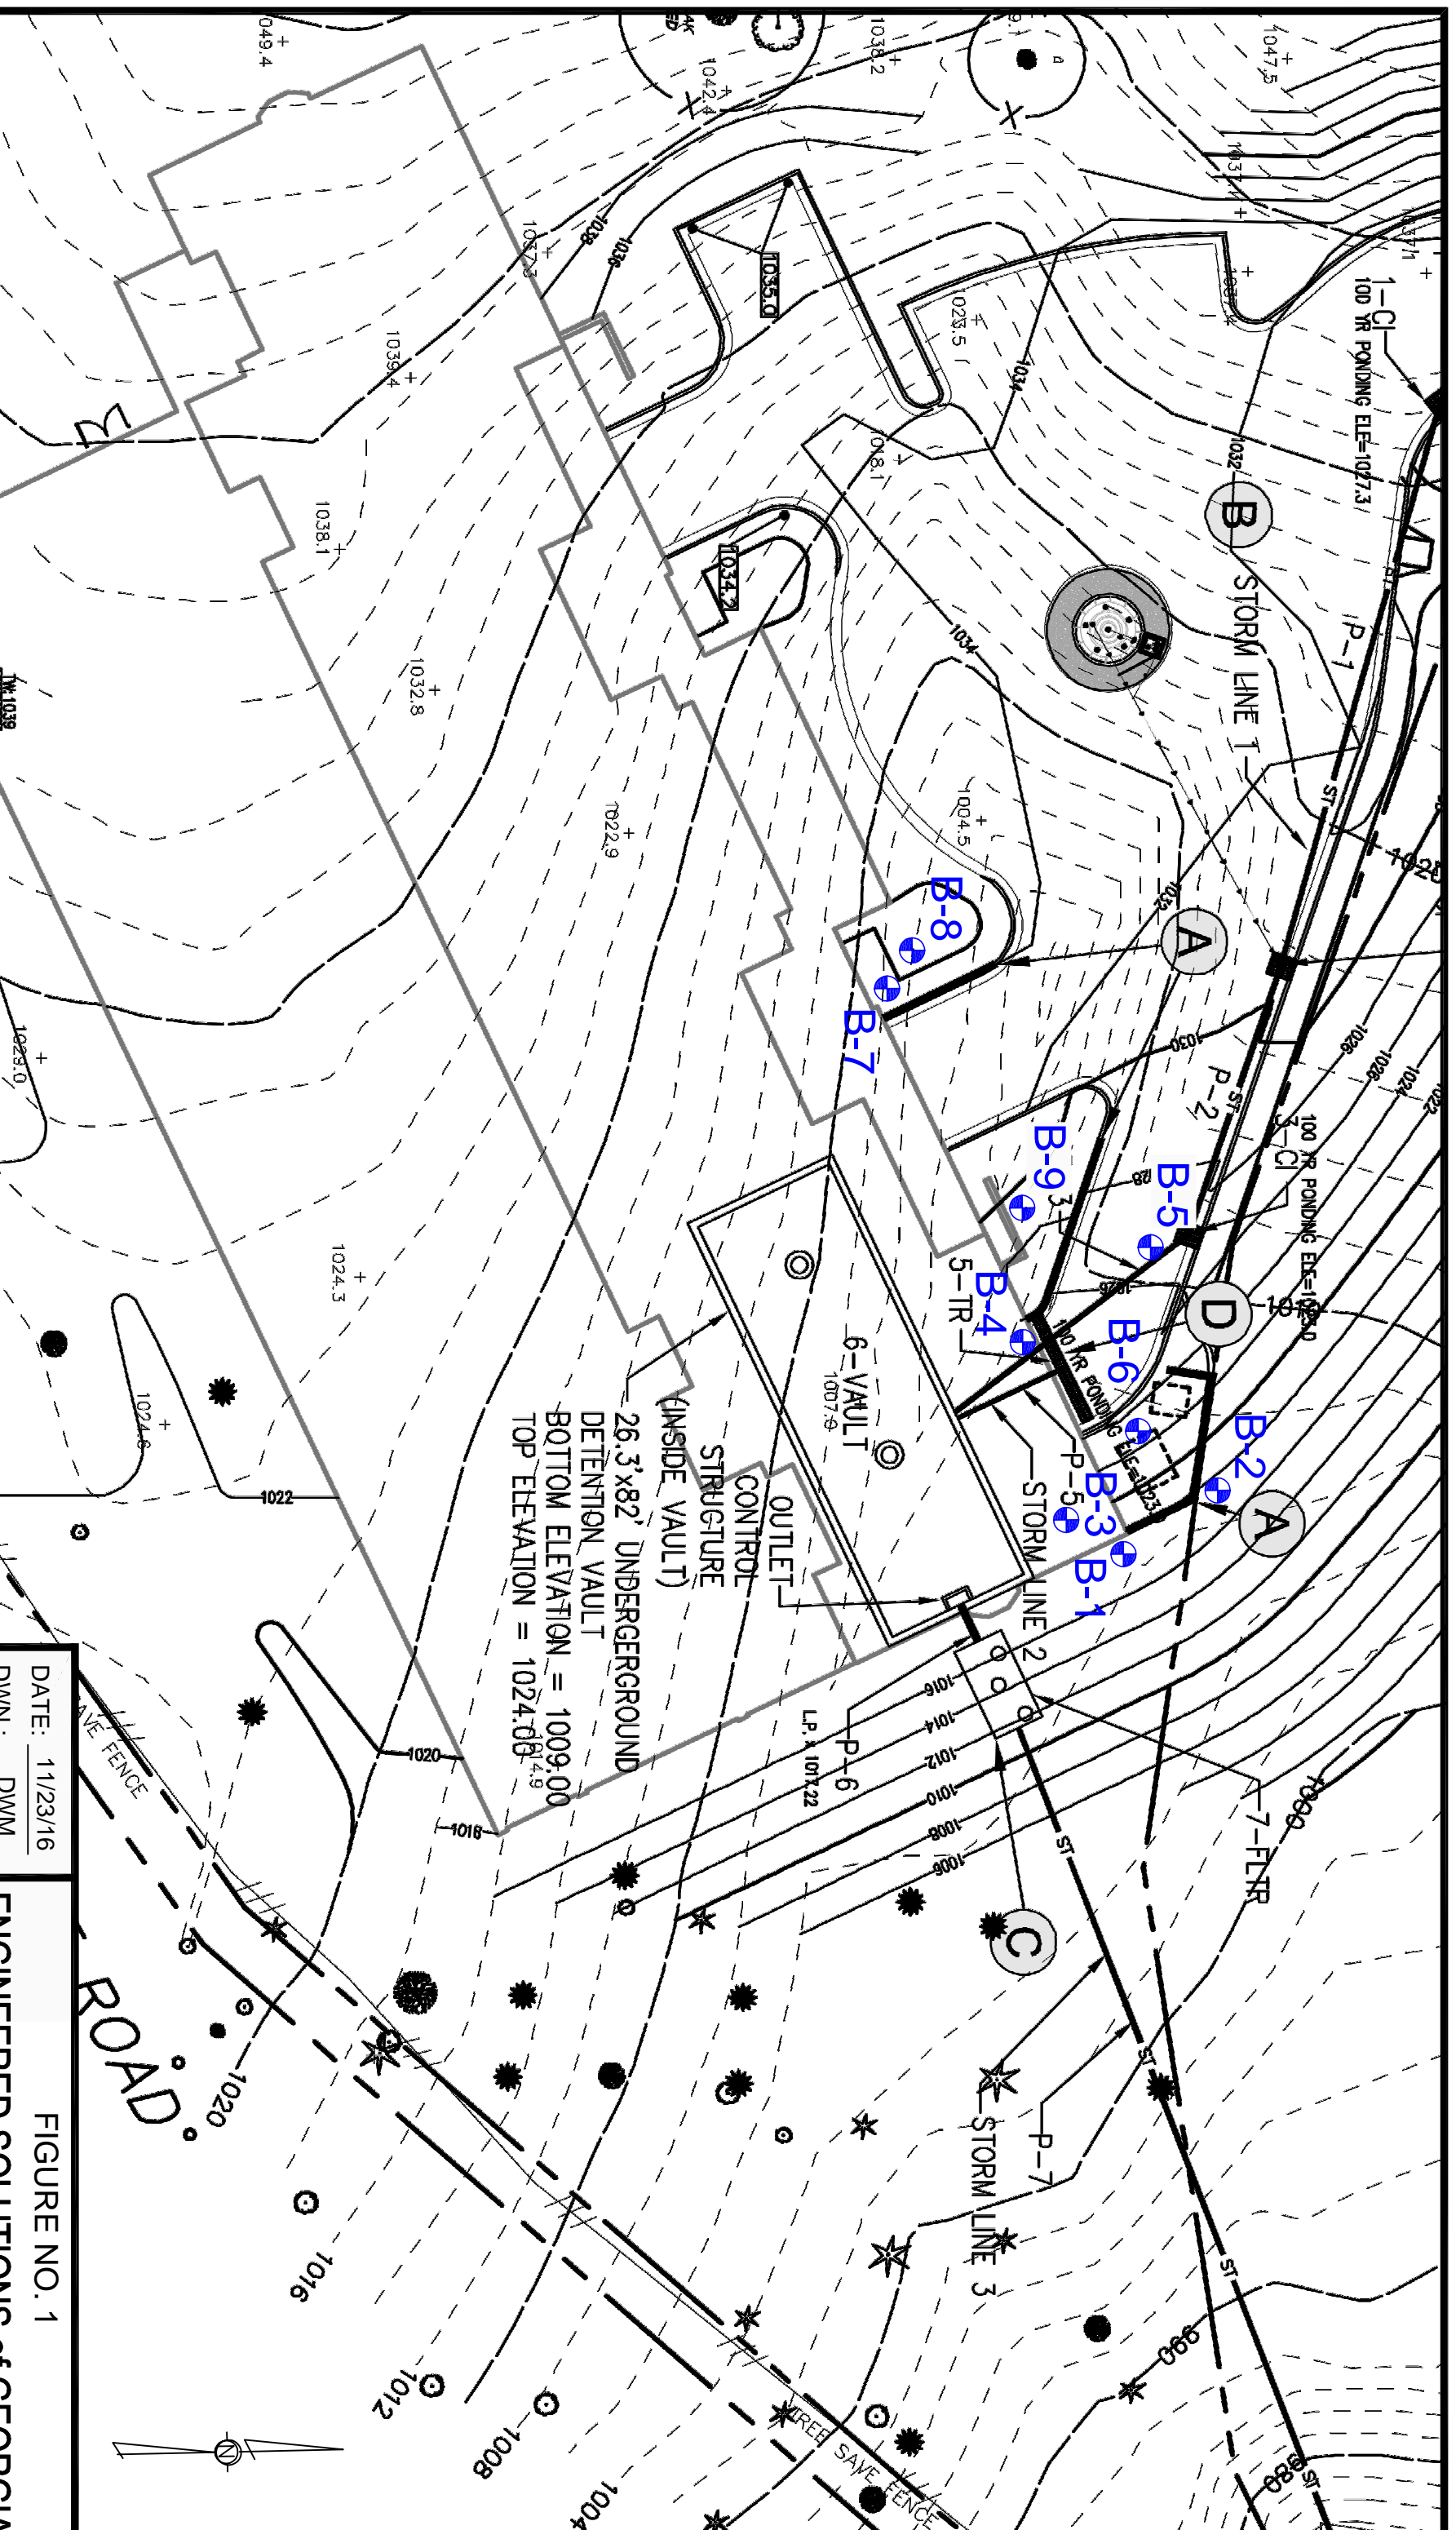
BORING LOCATION PLAN

A total of eight (8) boring locations were explored within or adjacent to the areas of observed distress. Based on our initial site visit, significant below grade utilities are present in the areas of the proposed exploration and a private utility contractor, RHD Services, Inc. was contracted to identify the location of underground utilities prior to selecting the specific boring locations. The initial borings were drilled on November 4, 2016. The borings were performed using hand auger techniques, which were proposed to be terminated at depths of 7 to 15 feet below the existing grades. Four of the borings were performed through 4 inch diameter cores through the existing pavements and the floor slab in the Main Electrical Room at the northeast corner of parking deck P1. These specific boring locations included the Main Electrical Room at the northeast corner of parking deck P1, The west side of the parking Deck P1 entrance where cracking is evident, near the eastern stormwater drop inlet within the entrance drive to parking deck P1 and the sidewalk area near the west side of the loading dock driveway. The remaining boring locations included the east side of the building at the north corner, near the base of the adjacent retaining wall north of this corner, the landscape area adjacent to the entrance to parking deck P1 and near the base of the exterior steps east of the loading dock driveway. The approximate boring locations are shown on the Boring Location Plans, Figures 1 & 2, attached with this report. The borings were located by our field engineer, who supervised the drilling operations and maintained logs of boring. The boring logs will indicate the depth, classification, relative density or consistency of the soils encountered, depth to rock or groundwater and any unusual subsurface conditions noted.

Due to significant rock fragments within the existing fill soil encountered, each of the hand auger borings encountered shallow refusal prior to penetrating the existing fill embankments. Numerous boring offsets were performed for the borings not located in the concrete areas that were cored. The hand auger boring depths ranged from 1 to 5 feet below existing grades. Dynamic Cone Penetrometer Tests were performed in each boring where obvious rock fragments were not encountered, to determine the relative densities of the soils encountered. It should be noted that the only boring which encountered a void beneath the existing pavements was located in the main electrical room, where a 4 inch thick void was present. The concrete thickness at the boring locations ranged from 4.8 inches in boring B-3 in the electrical room slab, to approximately 6 inches in boring B-7 in the sidewalk adjacent to the loading dock.

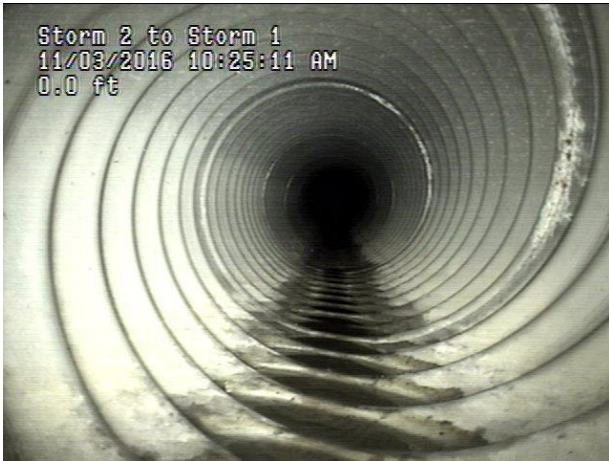
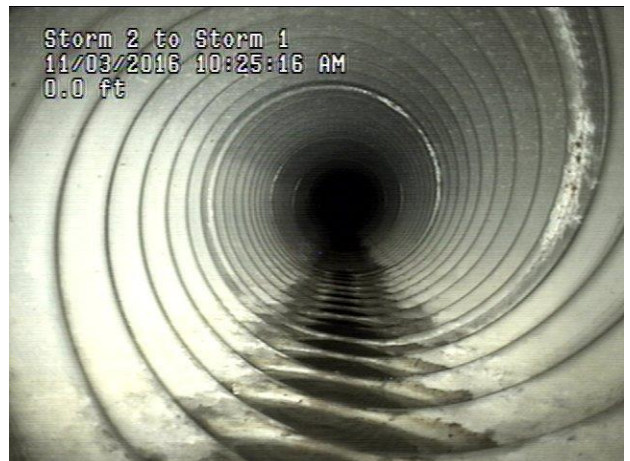
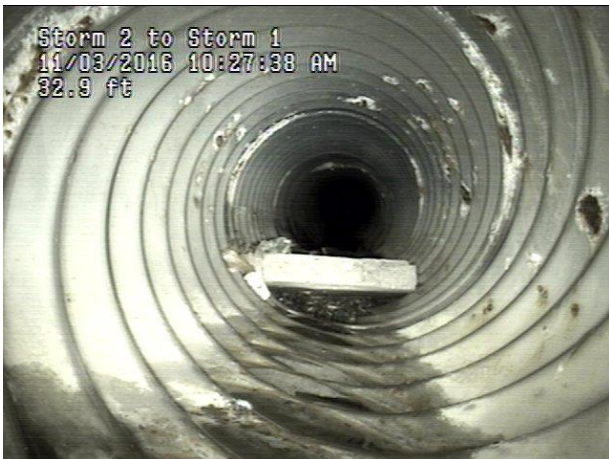
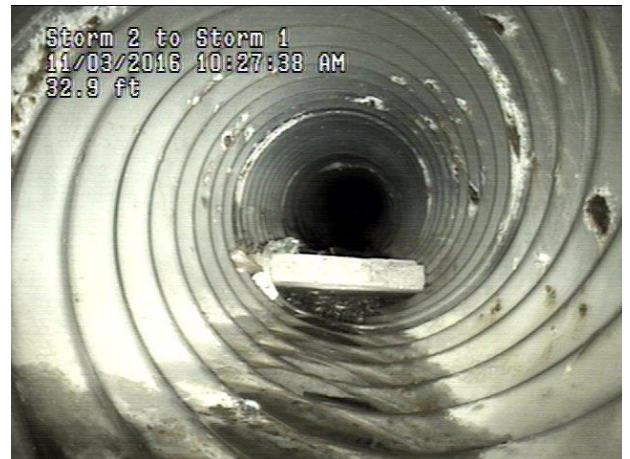
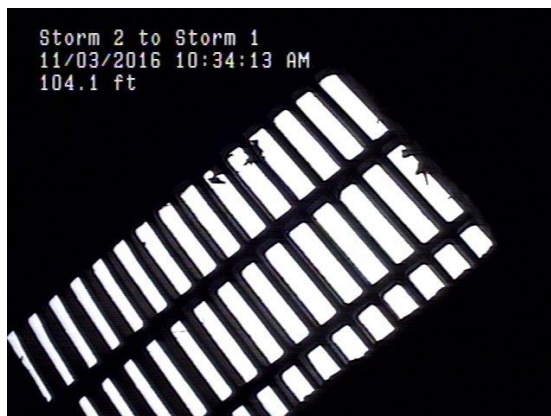
Storm 1 Pictures

Footage	Code	CD	Observation	At	To	V1	V2	%	Jt	Remarks	Img
<Start Inspection>											
0.0	AMH		Manhole							Starting manhole: Storm 2	X
0.0	MWL		Water Level					0			X
32.9	SCP		Surface Corrosion Meta...	10	5						X
33.5	OBZ		Obstacle Other	5	7			15		Loose Concrete	X
104.1	AMH		Manhole							Finishing manhole: Storm 1	X
<Complete Inspection>

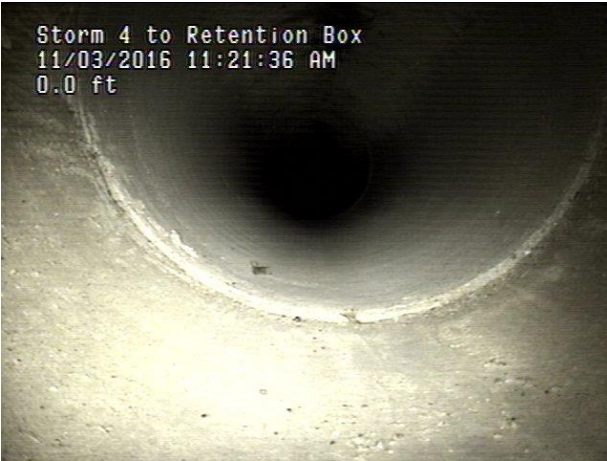
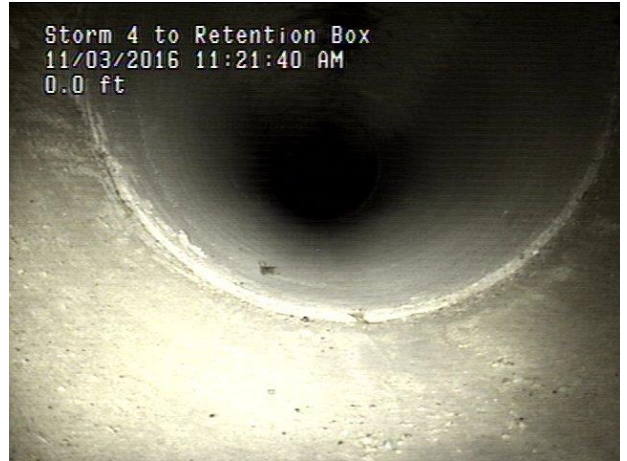
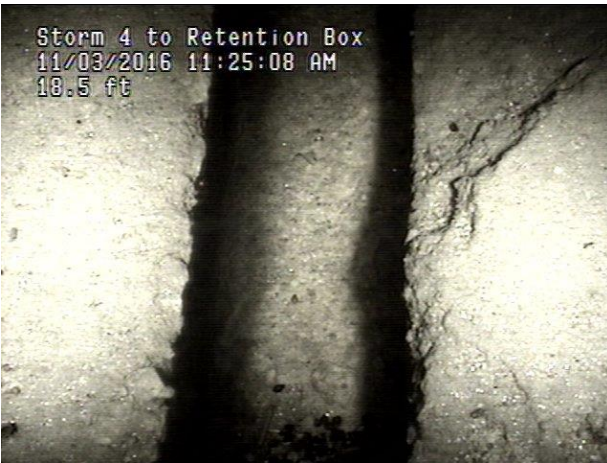
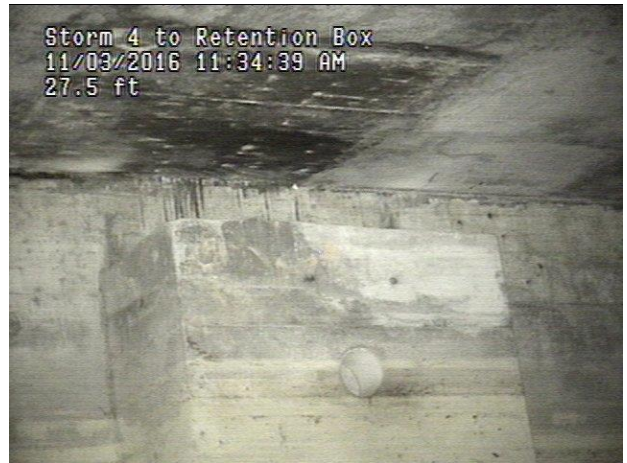
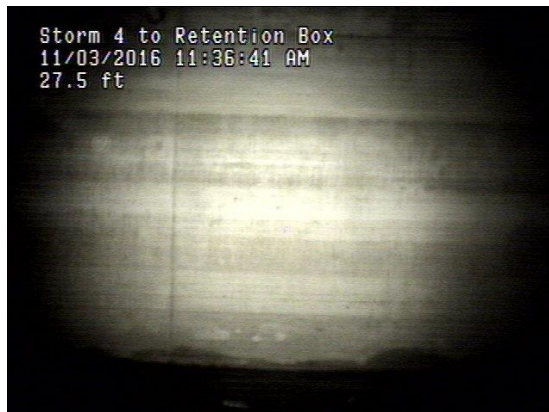
Storm 4 Pictures

With the exception of 1 area the Storm Water System appeared to be in pretty good condition. The area of question is a "Belly" or "Low Spot" with a separated joint between 2 pipe sections located between the drop inlet (Storm 4 in the report) near the overhead door just outside of the parking

garage and the underground Storm Water Detention Vault. All of the video inspection data is included later in this report.

The storm pipe draining to the underground detention vault that has separated should be repaired to prevent water infiltration into the backfill soils. This may be performed conventionally, by excavation and repairing the separated pipe, or may be repaired by installation of a pipe liner, provided that the required flow capacity of the pipe allows a reduction of the pipe section. We recommend that a contractor specializing in this service be consulted to determine the feasibility of this procedure and that the project civil engineer, Kimley-Horn and Associates be consulted to ensure that lining the pipe will not detrimentally affect the site drainage of the development.
