ENGINEERED SOLUTIONS

Piering Systems

Foundation Piering

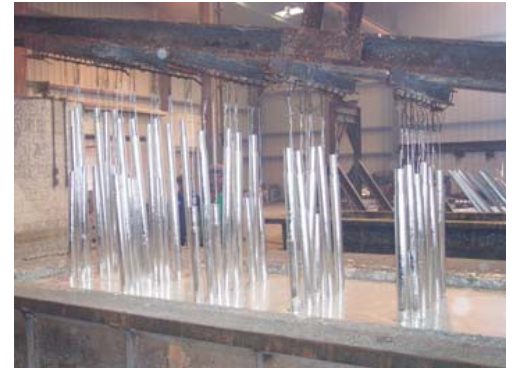
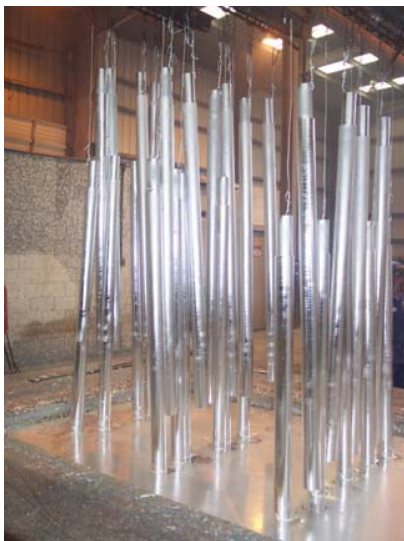
Although powder painted and unprotected steel can last for many years when submerged or buried, it must be FULLY covered, inside and out. Left unprotected, steel will react with its surrounding environment and revert to oxide compounds (rust), thus consuming the pier in the process.

While the outside of the pier is usually in contact with soil, which will provide some slowing of corrosion on the exterior, the interior of the pile is fully exposed and hollow. Only the bottom few feet of the piling will usually fill with soil during installation, but the remaining length will fill with ground water and air. In the area where the ground water stops, accelerated corrosion can occur, which can rapidly deteriorate and weaken the steel pile, reducing the useful life by years!

The same type of deterioration can occur with powder painted or spray painted material. These coatings are usually sprayed on and don't provide complete coverage inside and out. Corrosion will lift the coating over time, rendering its protection useless.

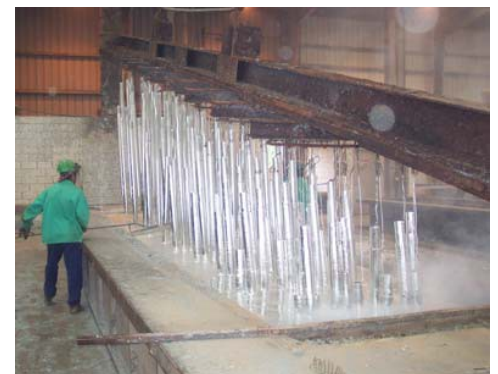
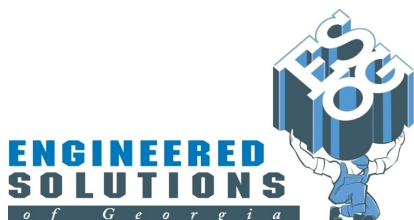
Galvanized products are put through a Hot Dipped Galvanizing process that completely submerges the entire product in a liquid coating of Zinc. Every part is protected, even recesses, sharp corners inside pipes, and inaccessible areas.

Galvanized coating has a unique metallurgical structure which gives outstanding resistance to mechanical damage that may occur during transport and installation. This coating provides a cathodic or sacrificial protection to small areas of steel exposed through damage. Unlike paint coatings, small damaged areas need no touch up.
