ENGINEERED SOLUTIONS

Piering Systems

Foundation Piering

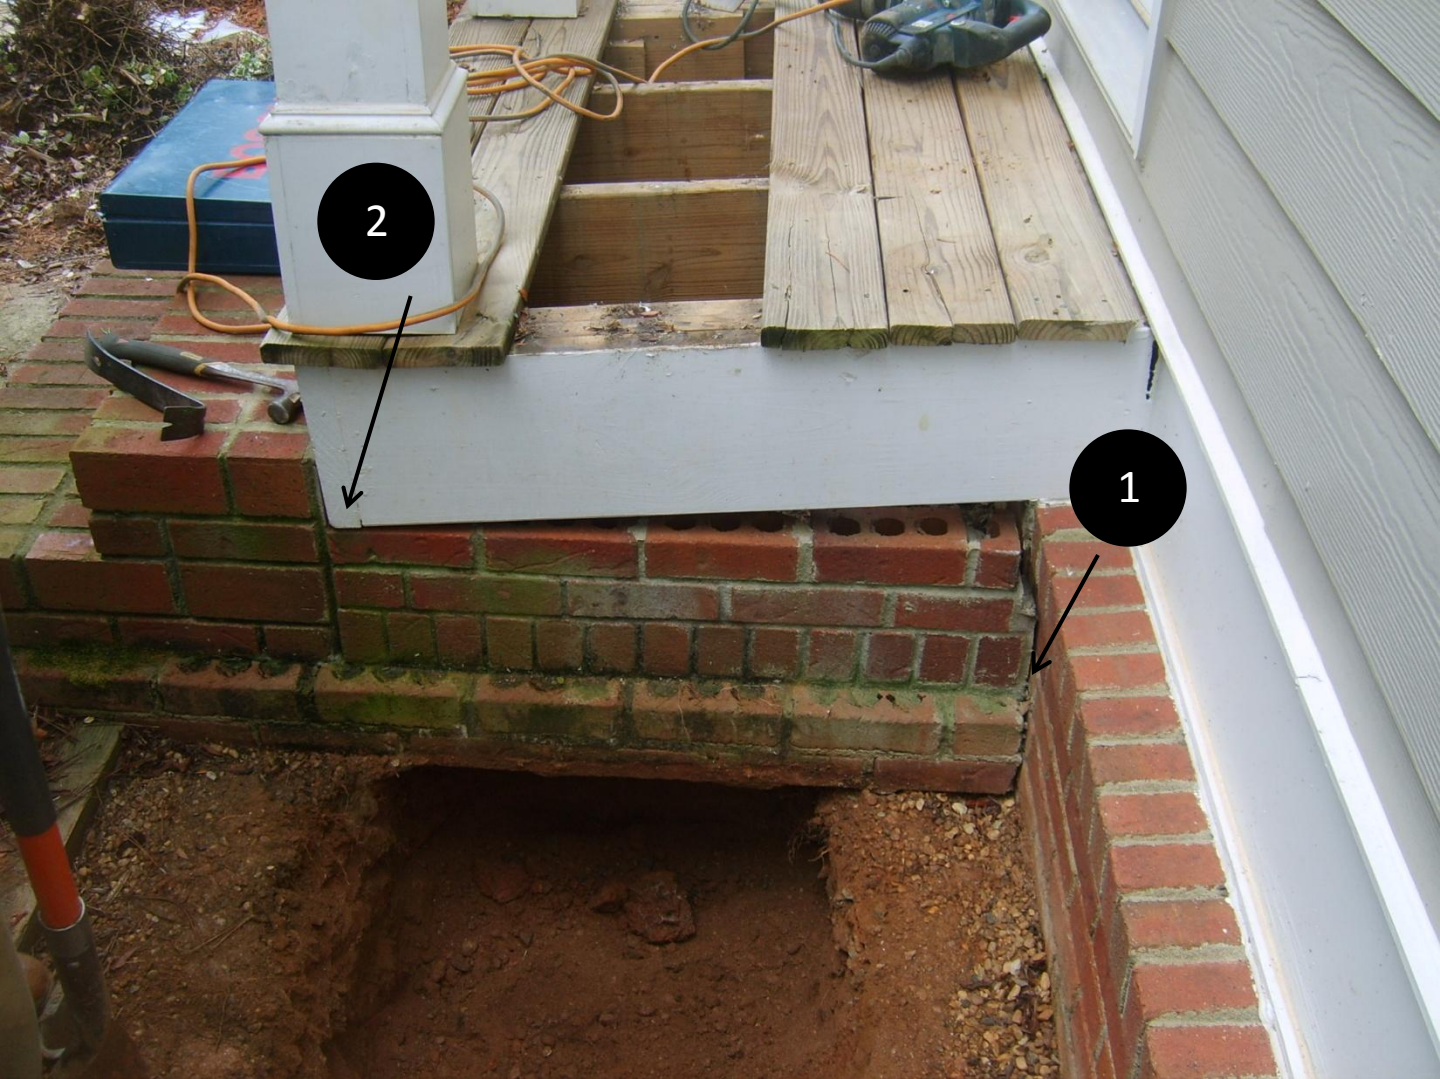
Stoop had settled

Pour soil under this stoop caused two things to happen

1. The back of this brick stoop settled pulling away from the house and the wooden deck.
2. The front portion of the deck had dropped down.

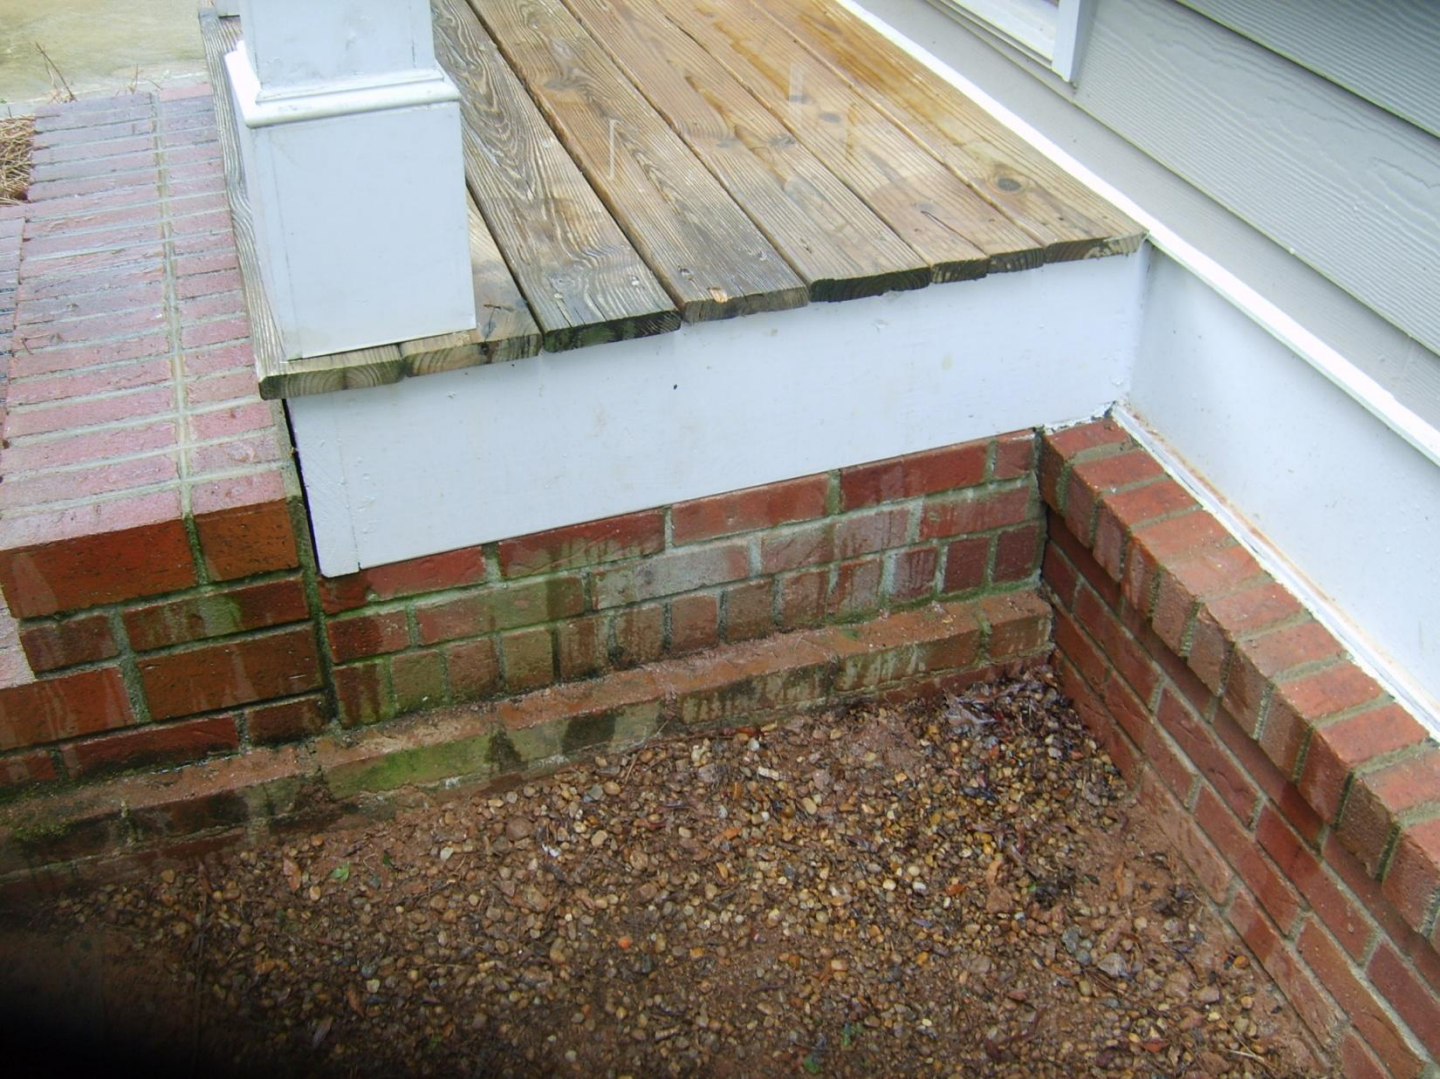
Stoop Recovered with Piering

Using galvanized helical piers we were able to save the stoop and return it to a more level position.

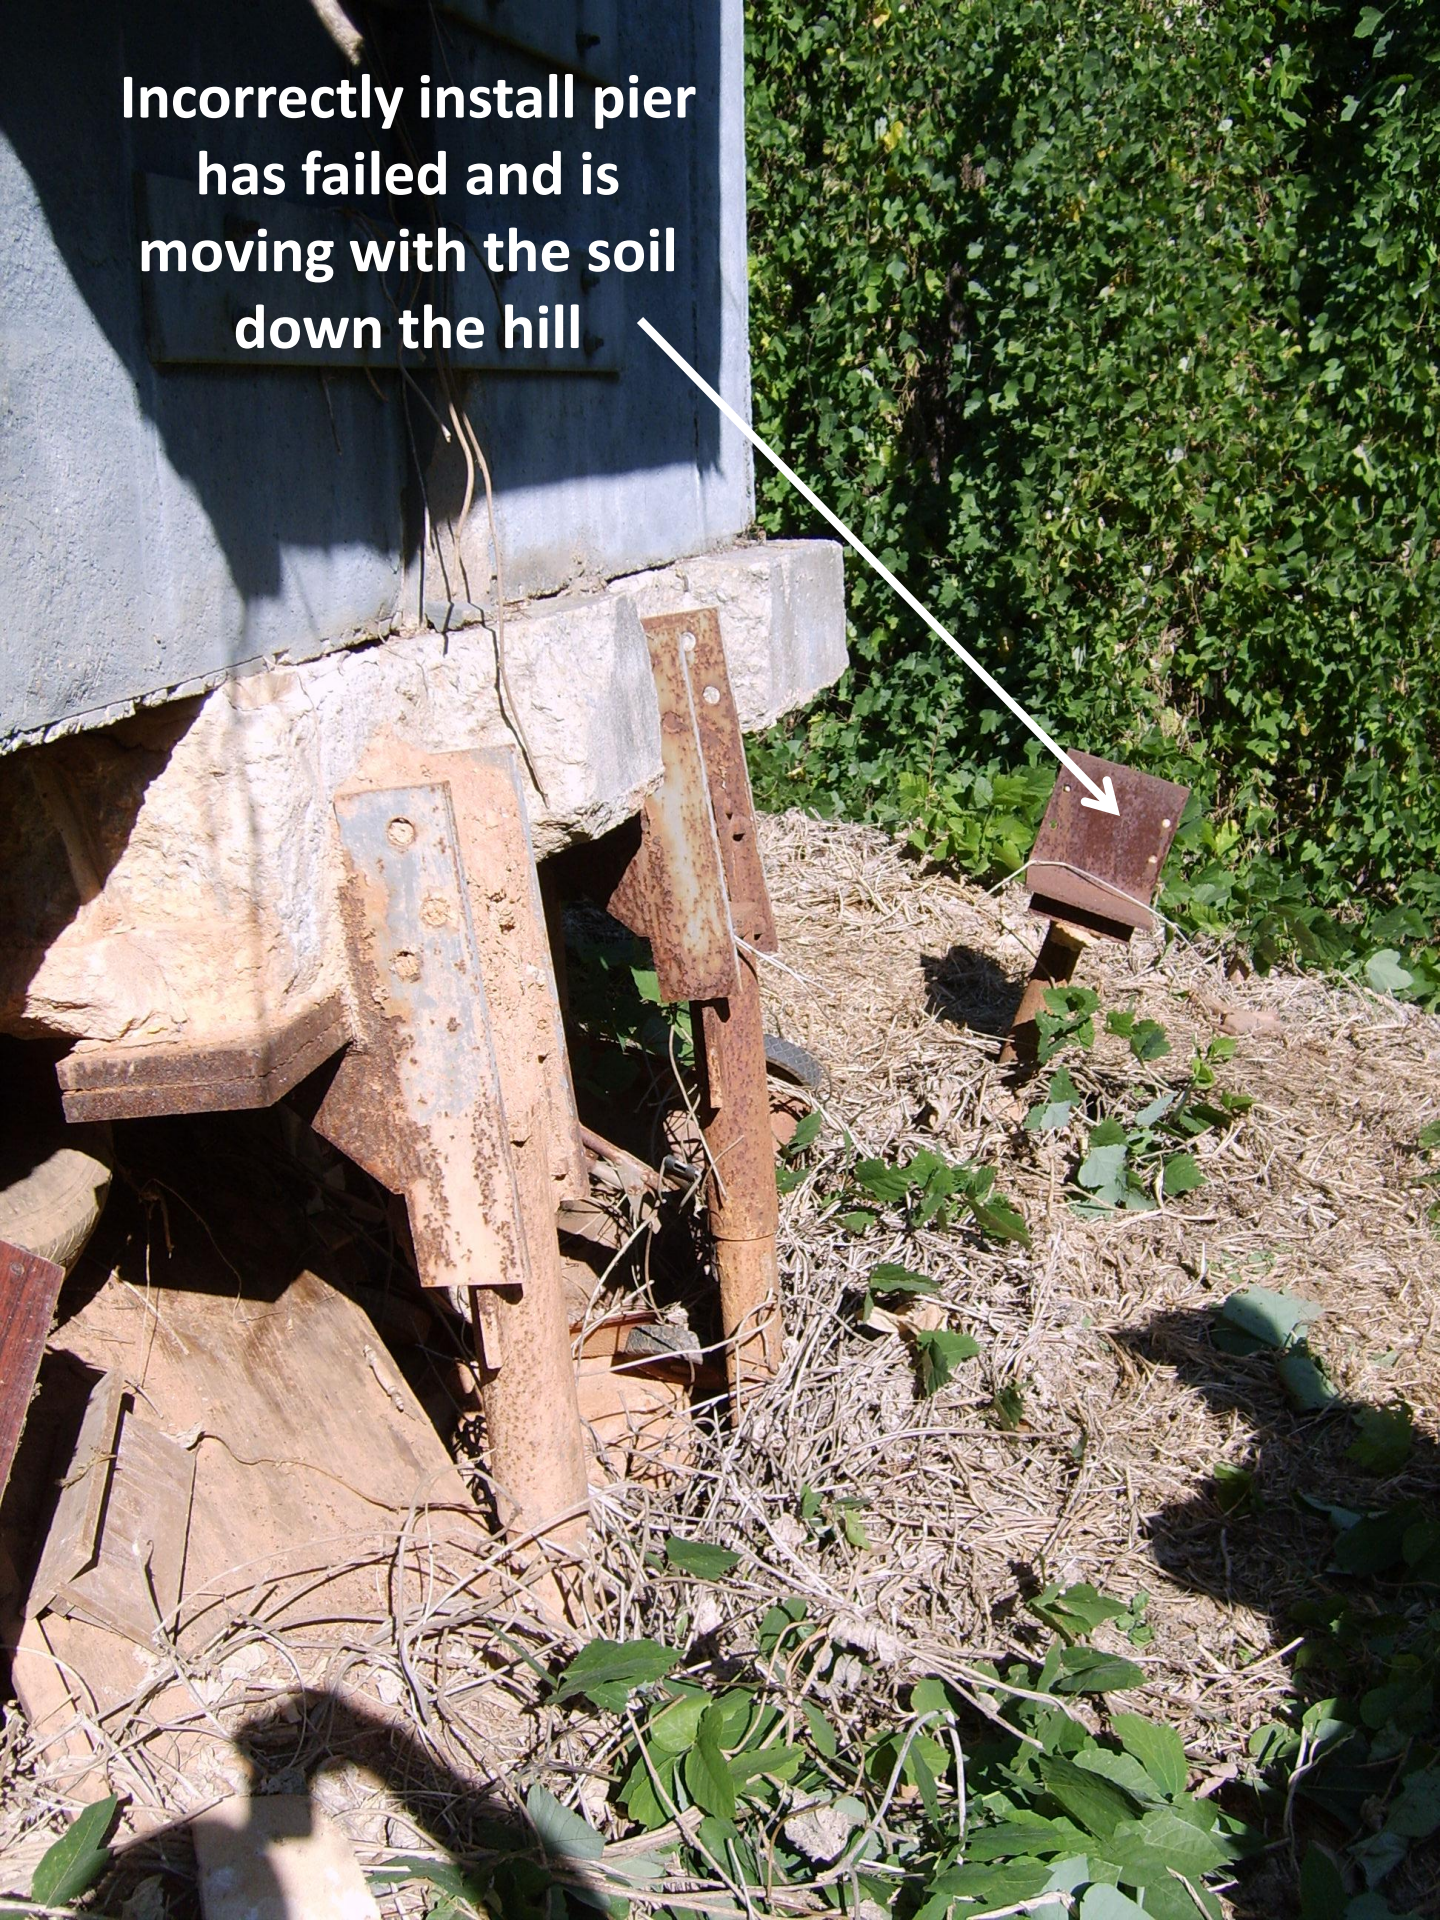
**Incorrectly install pier
has failed and is
moving with the soil
down the hill**
