Settlement Investigation

The Aberdeen

2700 Paces Ferry Road SE
Atlanta, GA 30339

**Pavement, Sidewalk, Site-Wall, Parking Garage/Electrical
Room and Storm Drainage
Settlement Investigation**

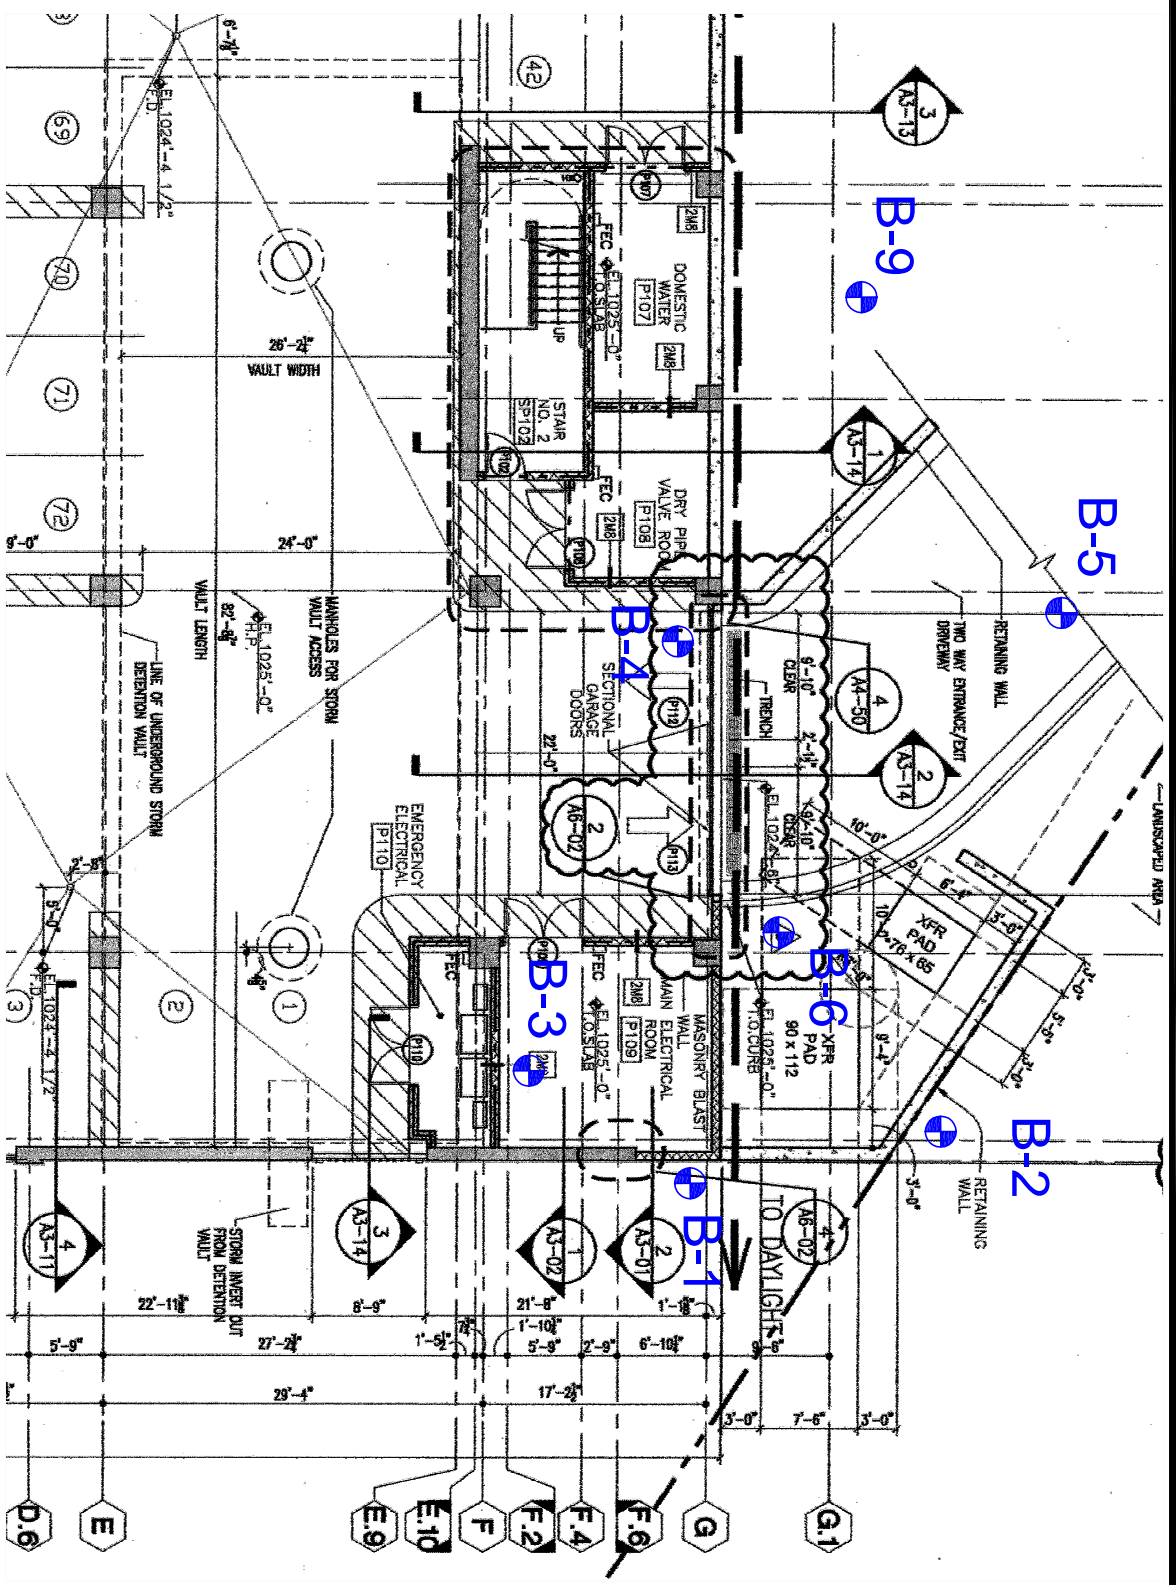
BORING LOCATION PLAN

A total of eight (8) boring locations were explored within or adjacent to the areas of observed distress. Based on our initial site visit, significant below grade utilities are present in the areas of the proposed exploration and a private utility contractor, RHD Services, Inc. was contracted to identify the location of underground utilities prior to selecting the specific boring locations. The initial borings were drilled on November 4, 2016. The borings were performed using hand auger techniques, which were proposed to be terminated at depths of 7 to 15 feet below the existing grades. Four of the borings were performed through 4 inch diameter cores through the existing pavements and the floor slab in the Main Electrical Room at the northeast corner of parking deck P1. These specific boring locations included the Main Electrical Room at the northeast corner of parking deck P1, The west side of the parking Deck P1 entrance where cracking is evident, near the eastern stormwater drop inlet within the entrance drive to parking deck P1 and the sidewalk area near the west side of the loading dock driveway. The remaining boring locations included the east side of the building at the north corner, near the base of the adjacent retaining wall north of this corner, the landscape area adjacent to the entrance to parking deck P1 and near the base of the exterior steps east of the loading dock driveway. The approximate boring locations are shown on the Boring Location Plans, Figures 1 & 2, attached with this report. The borings were located by our field engineer, who supervised the drilling operations and maintained logs of boring. The boring logs will indicate the depth, classification, relative density or consistency of the soils encountered, depth to rock or groundwater and any unusual subsurface conditions noted.

Due to significant rock fragments within the existing fill soil encountered, each of the hand auger borings encountered shallow refusal prior to penetrating the existing fill embankments. Numerous boring offsets were performed for the borings not located in the concrete areas that were cored. The hand auger boring depths ranged from 1 to 5 feet below existing grades. Dynamic Cone Penetrometer Tests were performed in each boring where obvious rock fragments were not encountered, to determine the relative densities of the soils encountered. It should be noted that the only boring which encountered a void beneath the existing pavements was located in the main electrical room, where a 4 inch thick void was present. The concrete thickness at the boring locations ranged from 4.8 inches in boring B-3 in the electrical room slab, to approximately 6 inches in boring B-7 in the sidewalk adjacent to the loading dock.

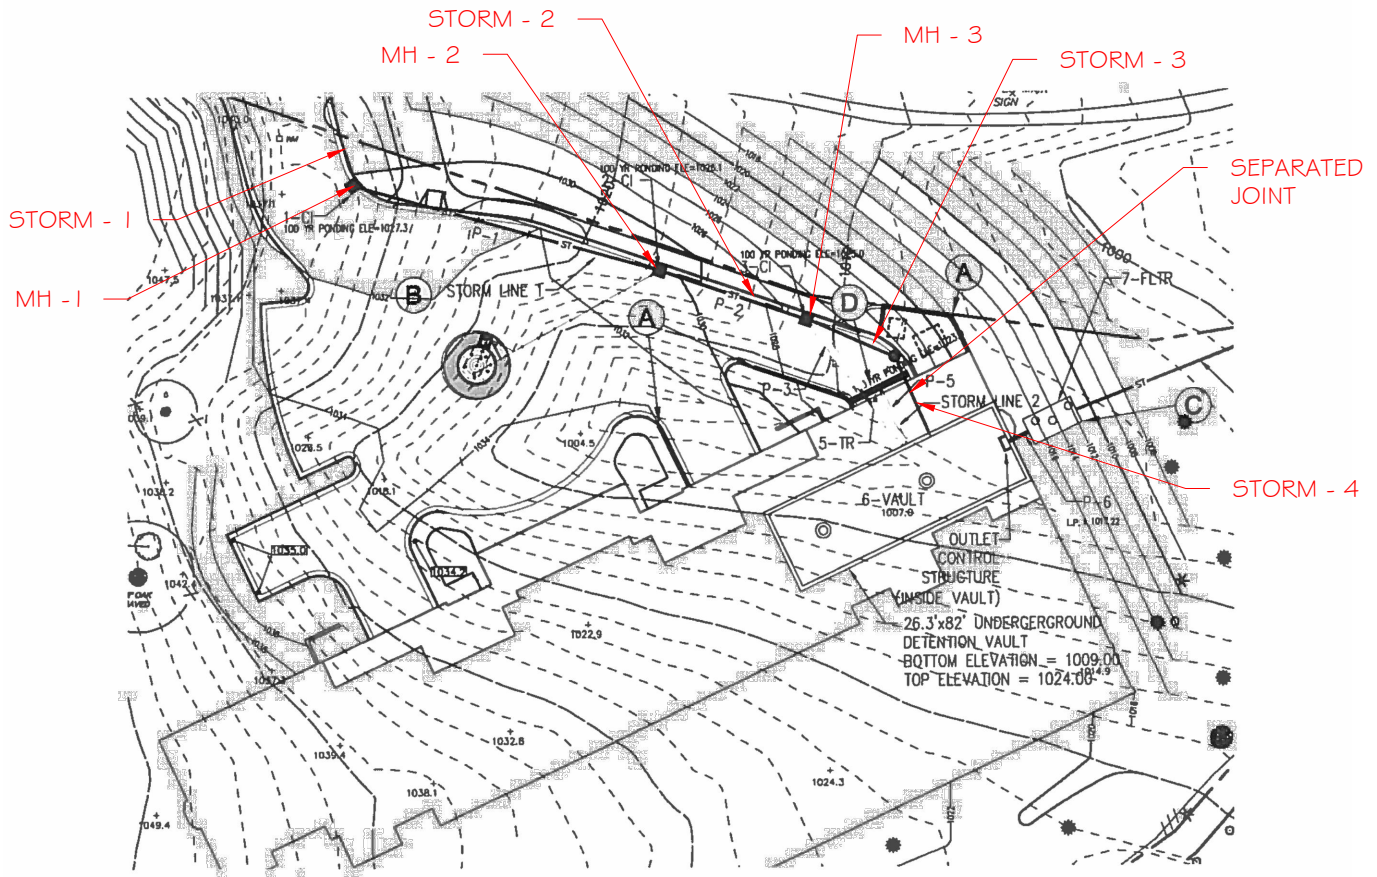
STORM LOCATIONS

With the exception of 1 area the Storm Water System appeared to be in pretty good condition. The area of question is a "Belly" or "Low Spot" with a separated joint between 2 pipe sections located between the drop inlet (Storm 4 in the report) near the overhead door just outside of the parking

garage and the underground Storm Water Detention Vault. All of the video inspection data is included later in this report.

The storm pipe draining to the underground detention vault that has separated should be repaired to prevent water infiltration into the backfill soils. This may be performed conventionally, by excavation and repairing the separated pipe, or may be repaired by installation of a pipe liner, provided that the required flow capacity of the pipe allows a reduction of the pipe section. We recommend that a contractor specializing in this service be consulted to determine the feasibility of this procedure and that the project civil engineer, Kimley-Horn and Associates be consulted to ensure that lining the pipe will not detrimentally affect the site drainage of the development.

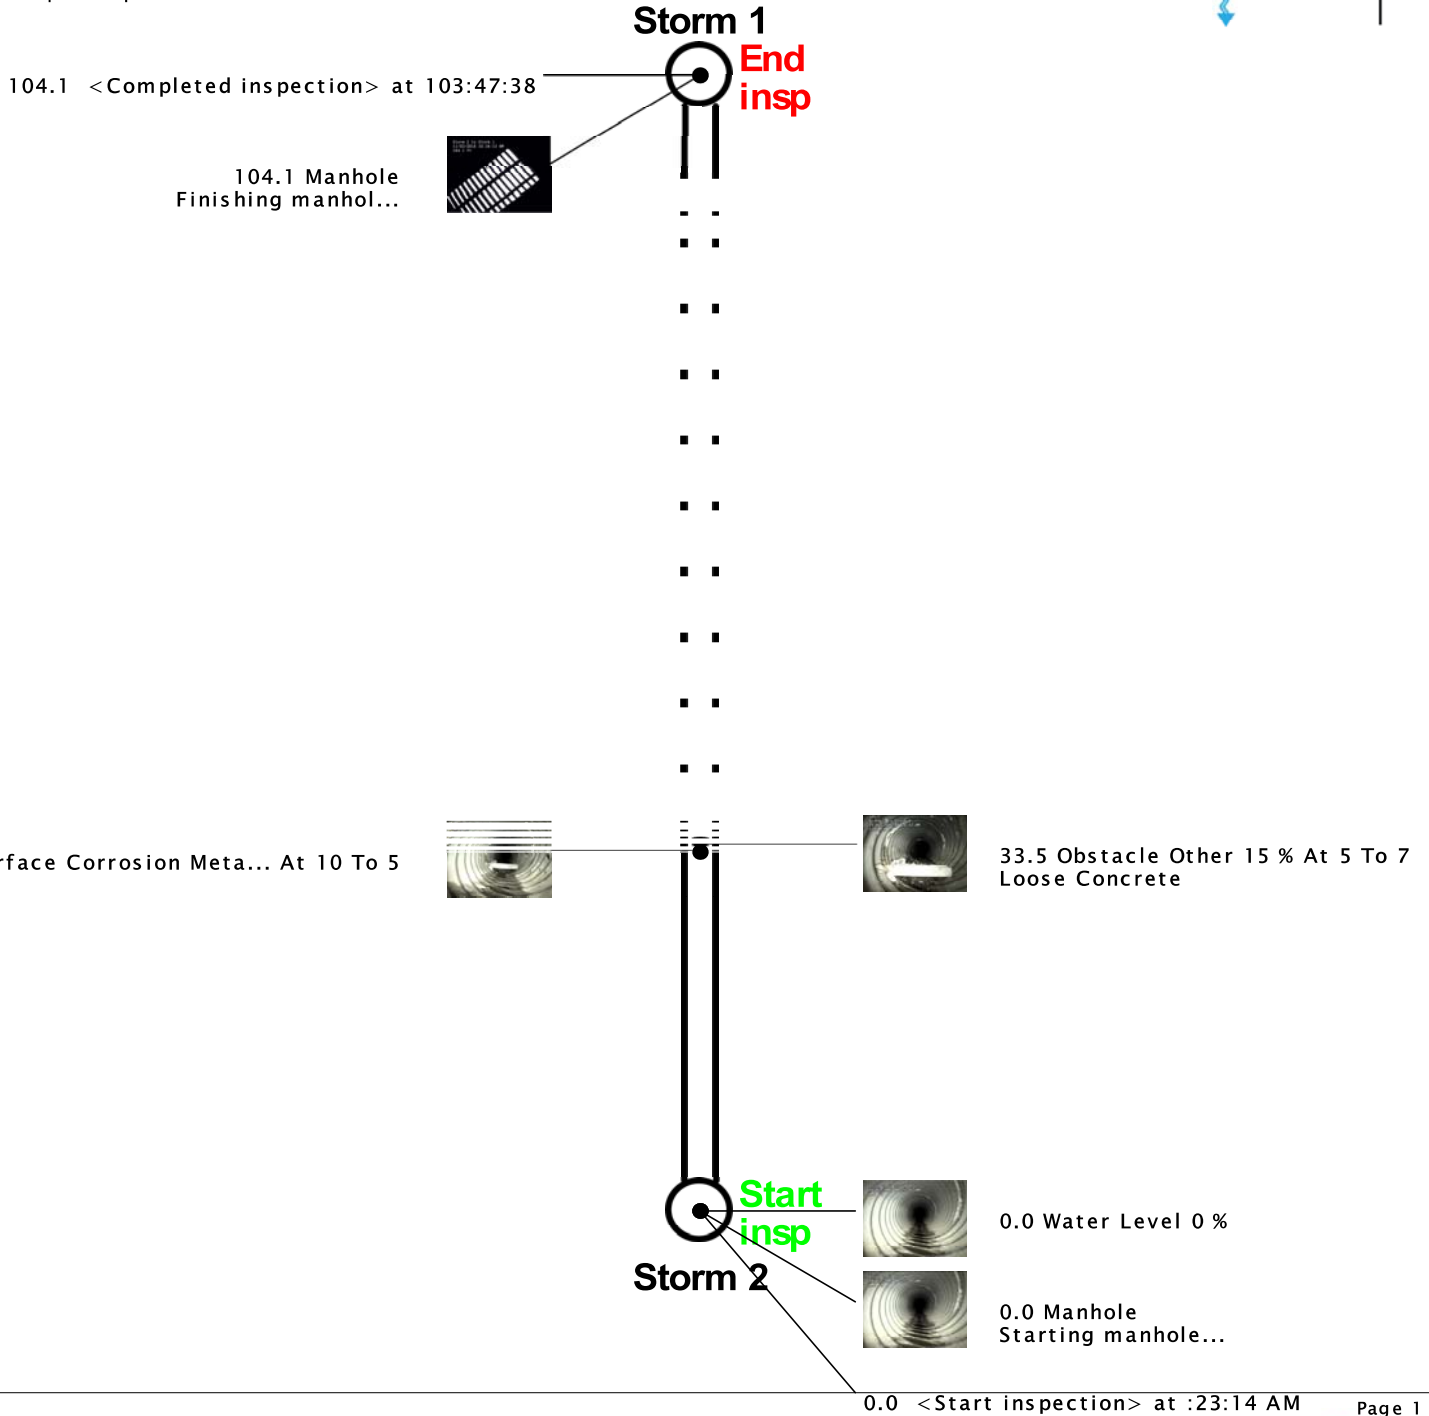
MH Storm 2 to Storm 1 Upstream Inspection

Footage	Code	CD	Observation	At	To	V1	V2	%	Jt	Remarks	Img
<Start Inspection>											
0.0	AMH		Manhole							Starting manhole: Storm 2	X
0.0	MWL		Water Level					0			X
32.9	SCP		Surface Corrosion Meta...	10	5						X
33.5	OBZ		Obstacle Other	5	7			15		Loose Concrete	X
104.1	AMH		Manhole							Finishing manhole: Storm 1	X
<Complete Inspection>
