NUSTAR ENERGY LTD

FUNCTIONAL SAFETY COMMITTEE

MINUTES OF MEETING

NOVEMBER 2016

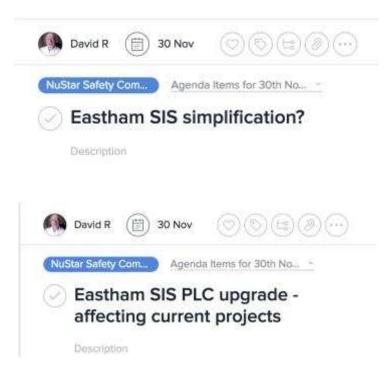
4.8.1 Eastham SIS

The committee discussed the number of modifications required to the SIS at Eastham, often resulting in one modification impacting on another. It was further established that in order to complete the Chloroform project a new logic solver would be required, as the existing cannot handle the analog inputs.

It was agreed to consider a simplification of the SIS, such that any tank IHLA would close all dockline valves. This should remove a lot of the requirement for modification to the SIS.

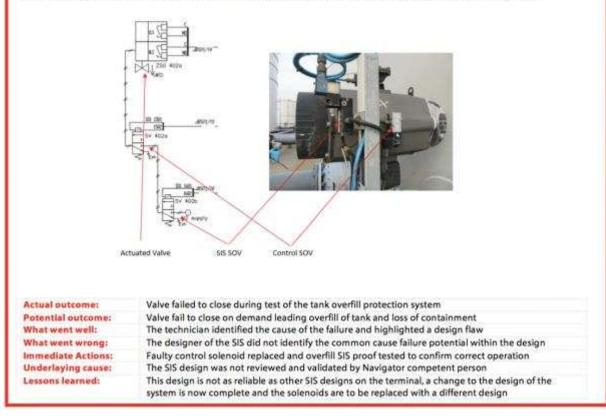
Incident: Failure of SIS System During Test

A SIS tank inlet valve failed to closed when commanded to do so from the SCADA control system. The control room operator requested maintenance to investigate the fault, the maintenance technician who investigated the fault could not close the valve, he isolated the nitrogen supply to the valve and the valve remained open, he then activated the tank high level trip to try and close the valve, the valve still failed to close.

An investigation into the failure was carried out and the fault was identified as a failure of the control solenoid valve. The solenoid valve shuttle had jammed preventing release of the nitrogen through the solenoid valve vent port, this prevented the actuator from closing the valve.

The diagram below shows the design of the SIS valve control and SIS solenoids. The control solenoid is nearest the valve actuator and the SIS solenoid is remote from the actuator. This design caused an indirect failure of the SIS due to the failure of the control solenoid valve.

It is clear that if the SIS solenoid valve was installed nearest the actuator this failure would not have resulted in failure of the SIS.
