When applied and maintained properly, Airide® springs can provide thousands of miles of trouble-free service. Most failures are caused by a lack of suspension maintenance or improper application. This is a guide to common air spring failures that are not covered by warranty.

Warranty Evaluation Criteria

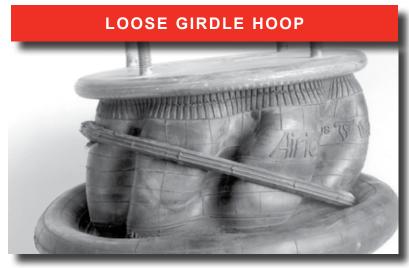
Rubber bellows distorted and girdle hoop torn loose

Running at extended positions with low air pressure

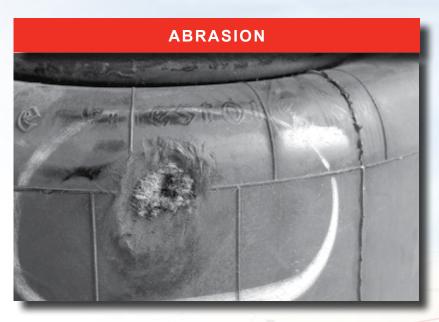
- Hole rubbed into side of bellows
- Hole in bellows area that rolls over piston (reversible sleeve style)

- Structural interference, such as:
 - -broken shock
 - -loose air line
 - -misalignment
 - -worn bushings
- No air pressure (reversible sleeve style)
- · Foreign material (sand, rocks, etc.)
- Wrong air spring

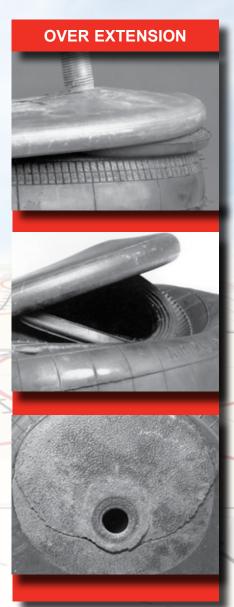
- Bead plate convex, especially around blind nuts or studs
- Rubber bellows separated from bead plate
- Leaking at blind nuts or studs
- Leaking at end closure (reversible sleeve)
- Loose girdle hoop on convoluted style

- Broken or wrong shock absorber
- Defective leveling valve
- Ride position too high
- Defective upper stop (lift)
- Wrong air spring (too short)
